# Performance of Structural Insulated Panel Walls under Seismic Loading

Research Paper  
FPL–RP–704

September  
2020

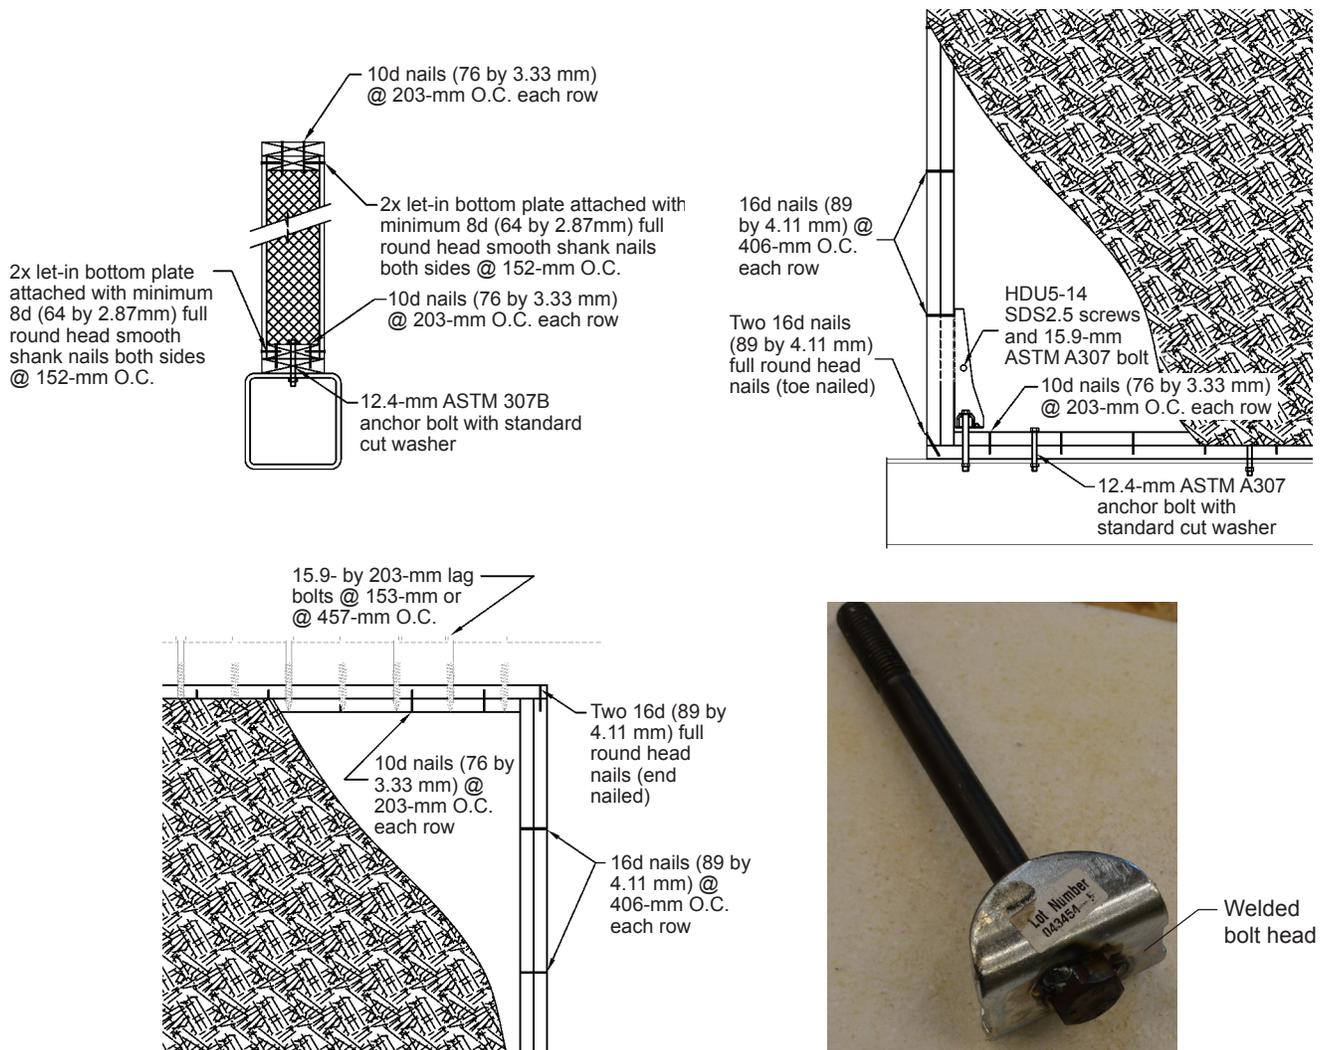
Figure 1. Construction details for all SIP wall configurations.

Although the research project can be broken into three distinct configuration features, all specimens were 2.4-m (8-ft) tall and constructed with common attributes. The nailing schedule, end-posts, hold-downs, and spline configurations were consistent across all specimens. Common features will be discussed followed by details specific to each of the three distinct configurations. Table 1 lists the common construction details, and Table 2 lists the fastening schedules for all the constructed walls. Figure 1 shows the general construction details consistent for all of the constructed single- and multiple-panel walls.

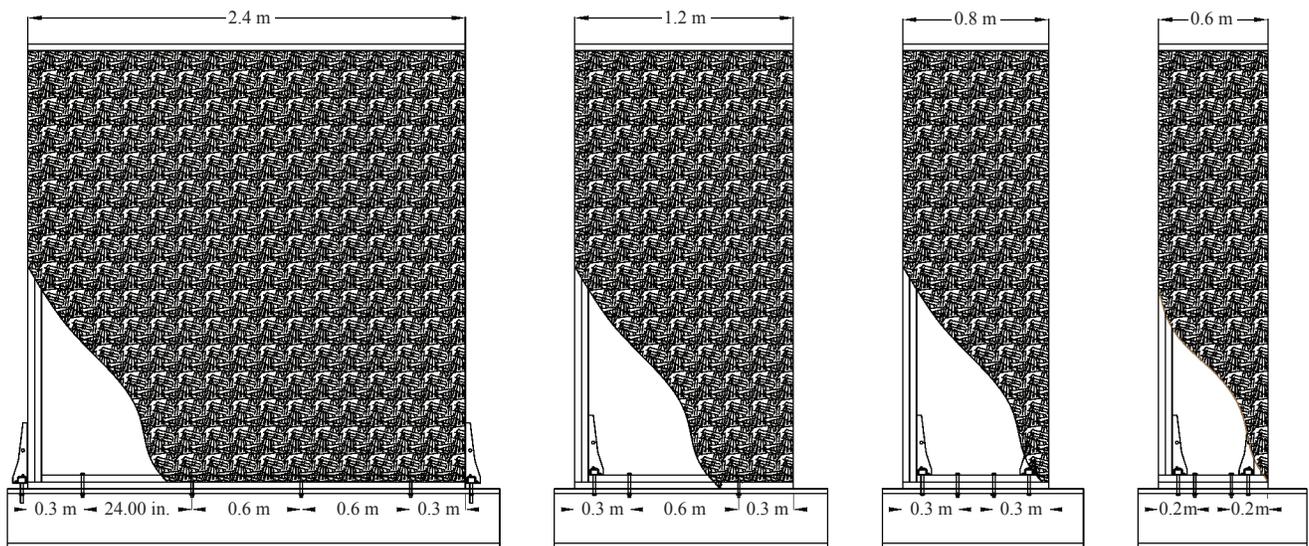
Figure 2. Wall configuration for single-panel SIP wall tests with and without hold-downs.

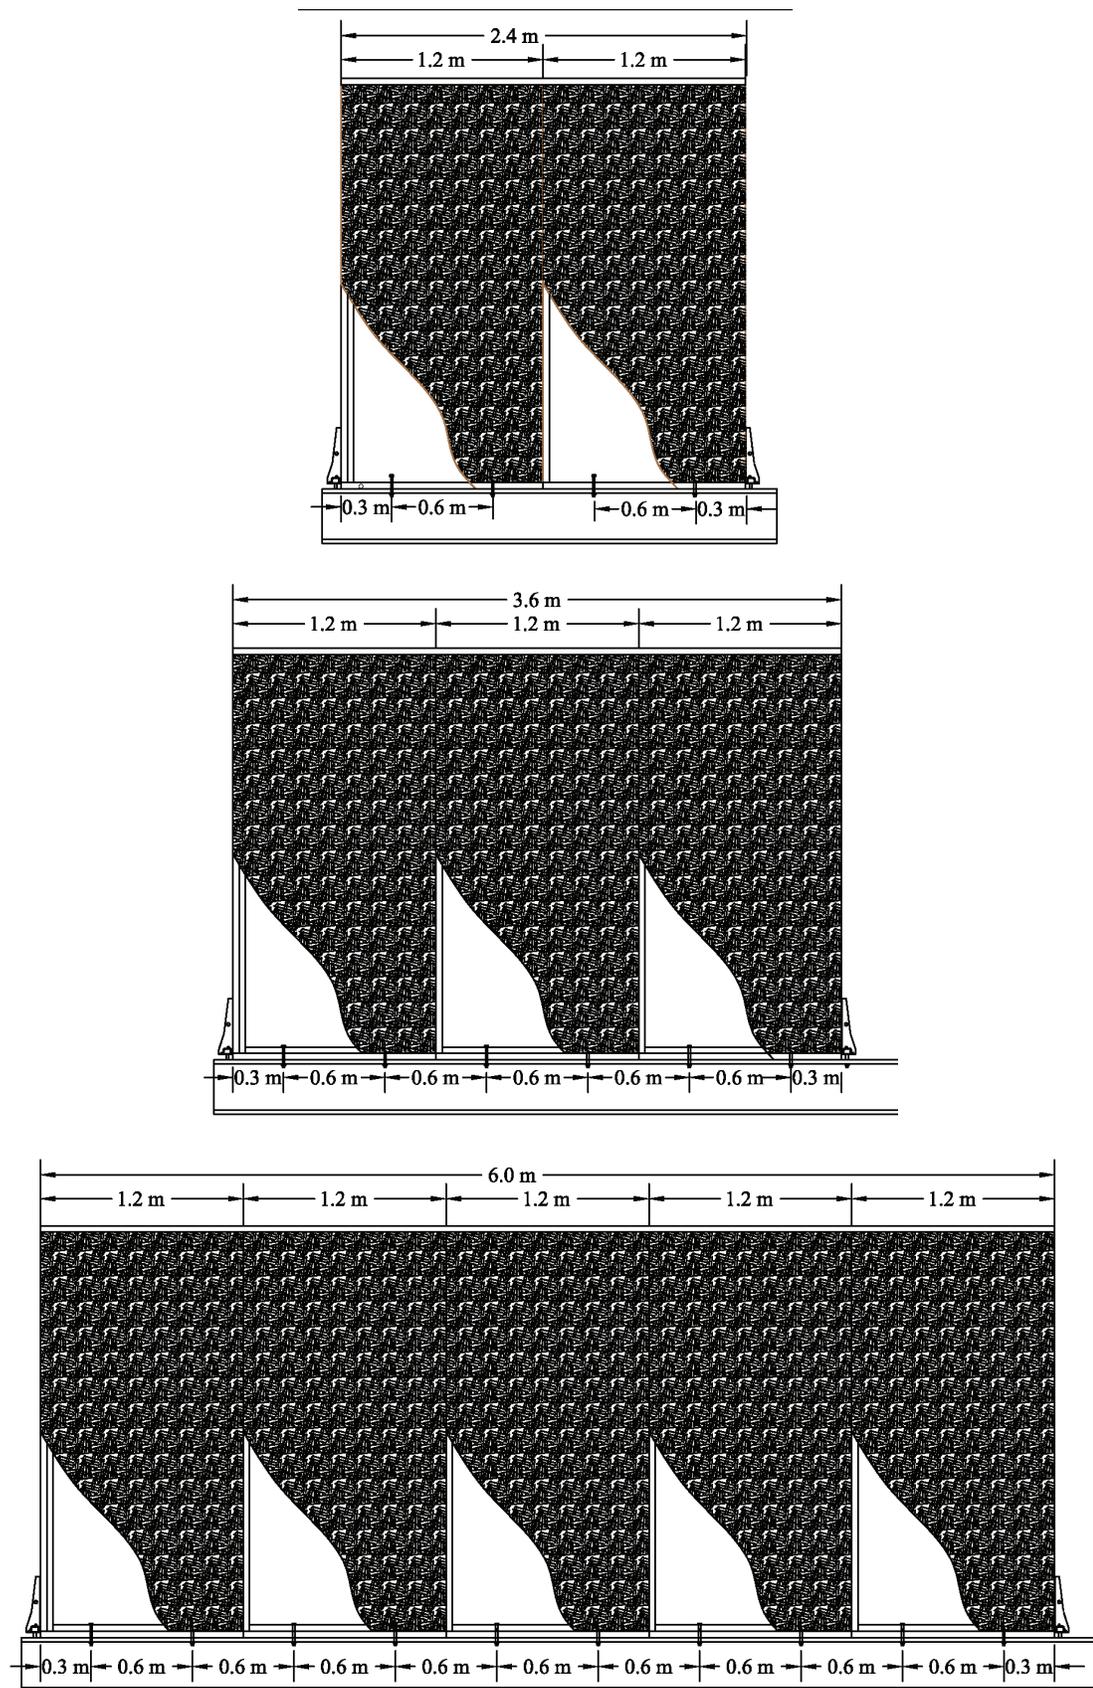
Figure 3. Configurations for multiple-panel SIP walls without openings.

Most SIP wall lines are constructed with a series of interconnected individual panels. Three multiple-panel walls of varying total length (2.4, 3.6, and 6 m (8, 12, 20 ft)) using a block spline configuration were evaluated (Figs. 3 and 4). Each 1.2- by 2.4-m (4- by 8-ft) single panel for all the multiple-panel specimens contained two anchor bolts. The let-in framing and cap plate or sill plate framing were continuous across all spline joints. Butt joints were staggered to avoid introducing a vulnerability at the same location. Hold-downs were only placed at the end

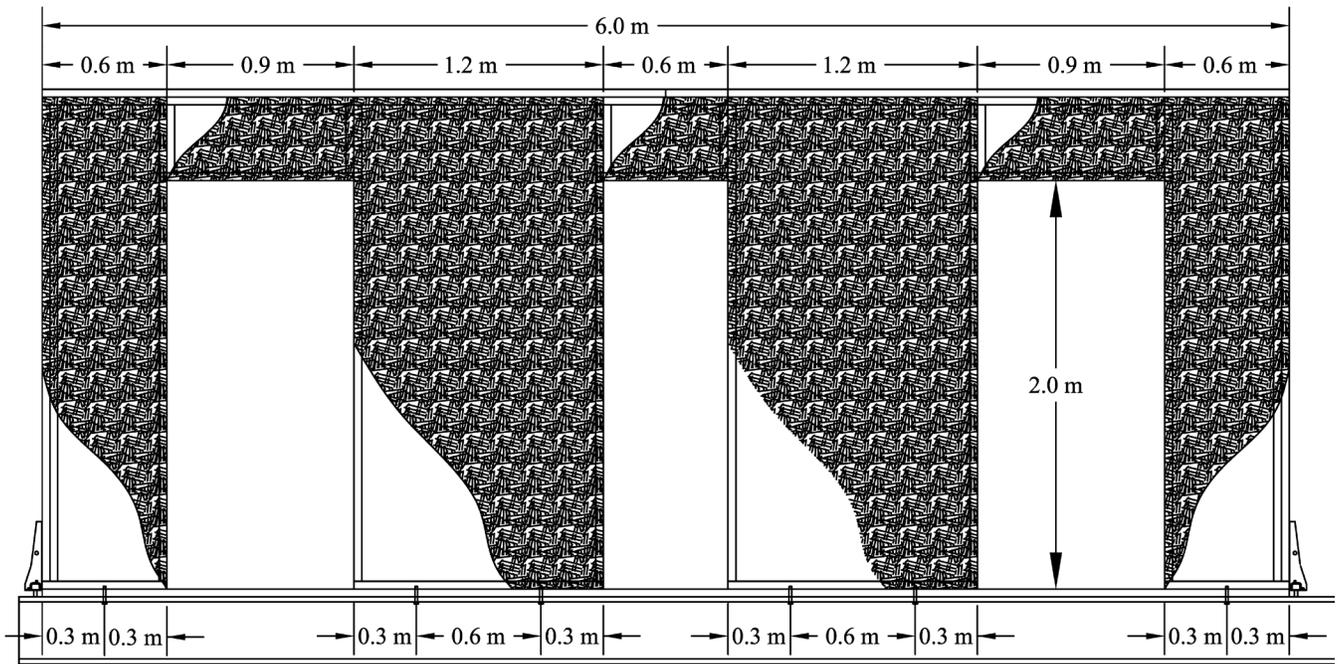
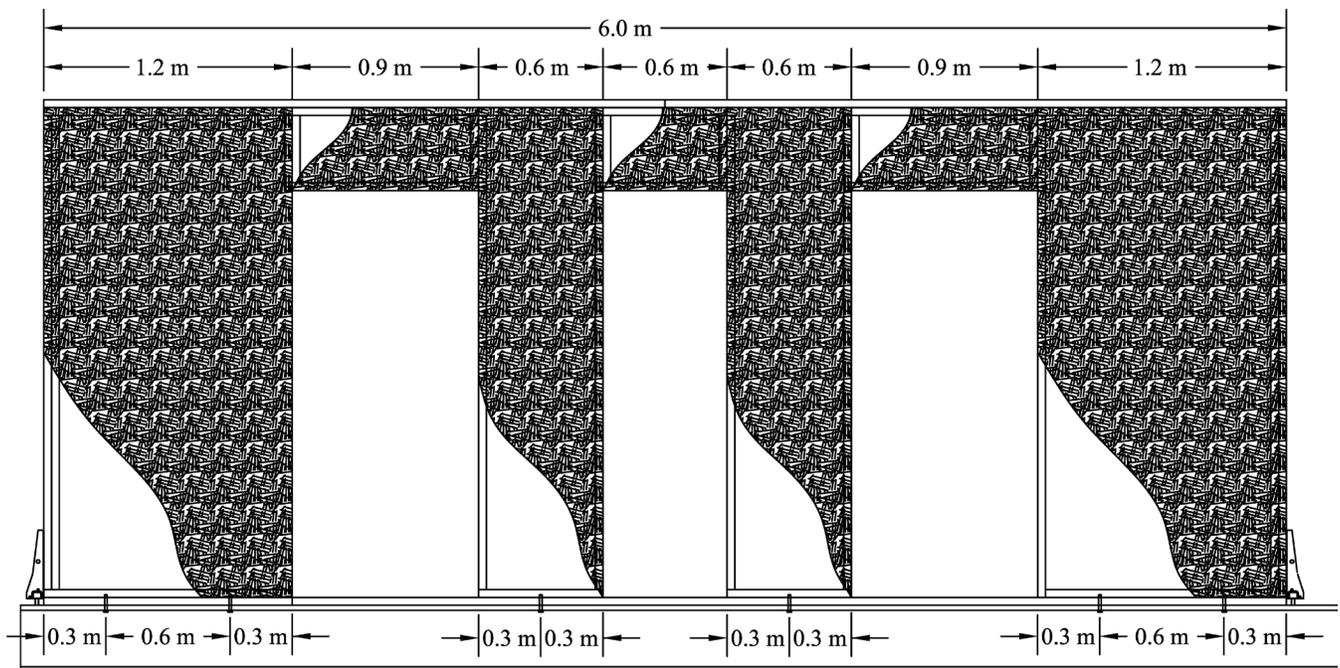
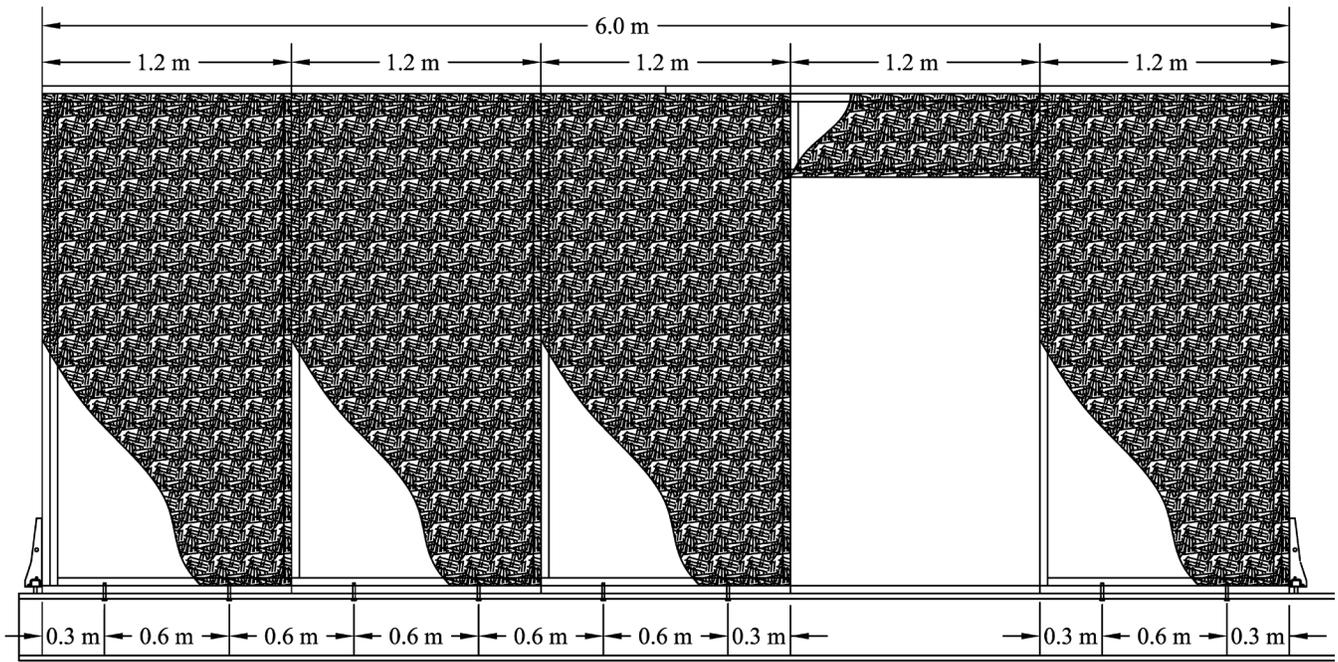
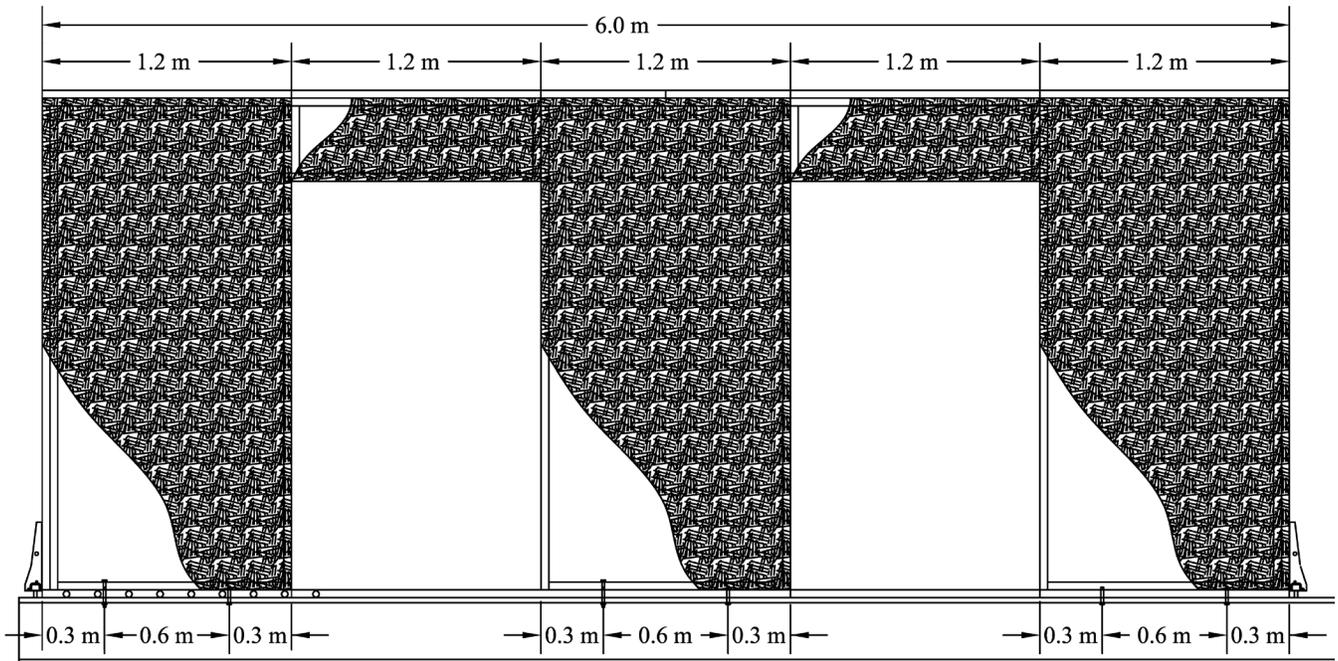
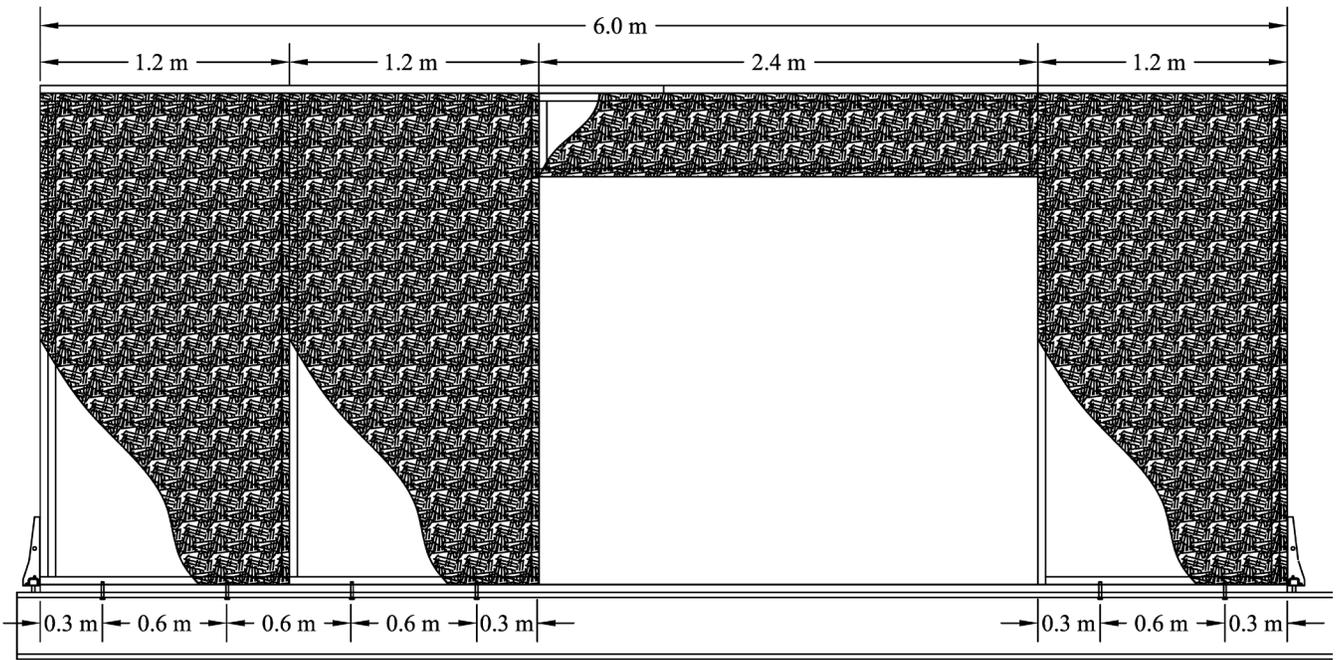
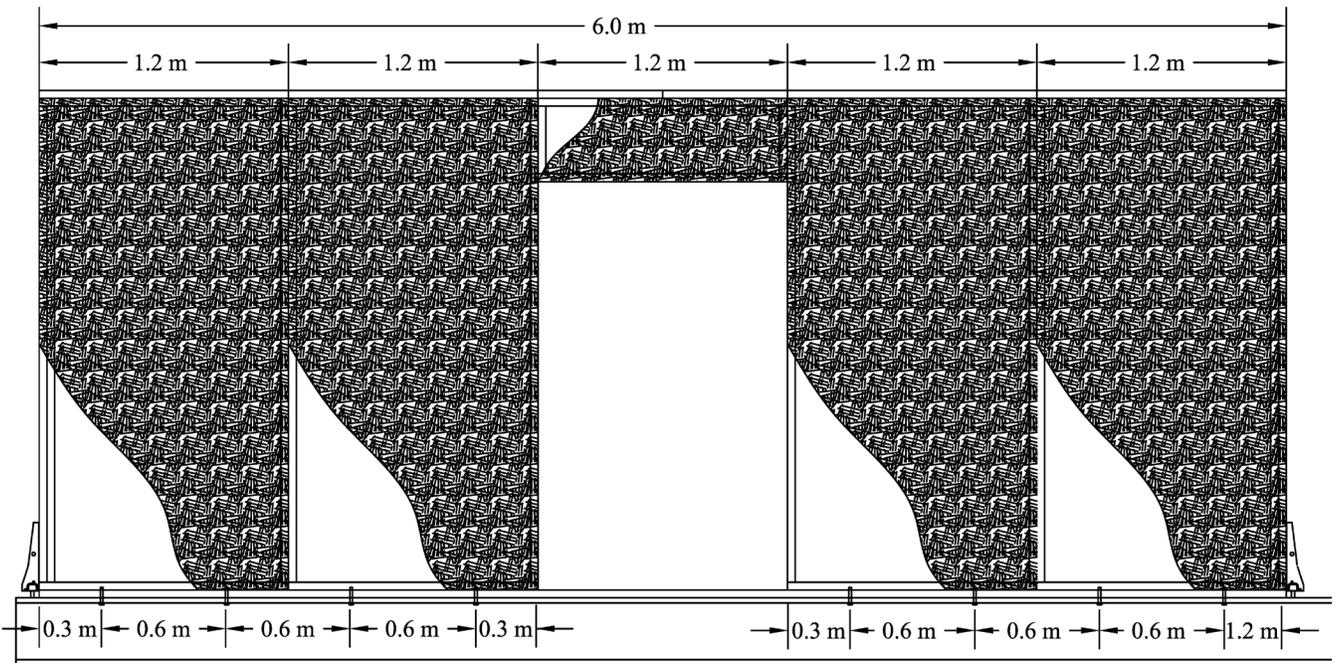
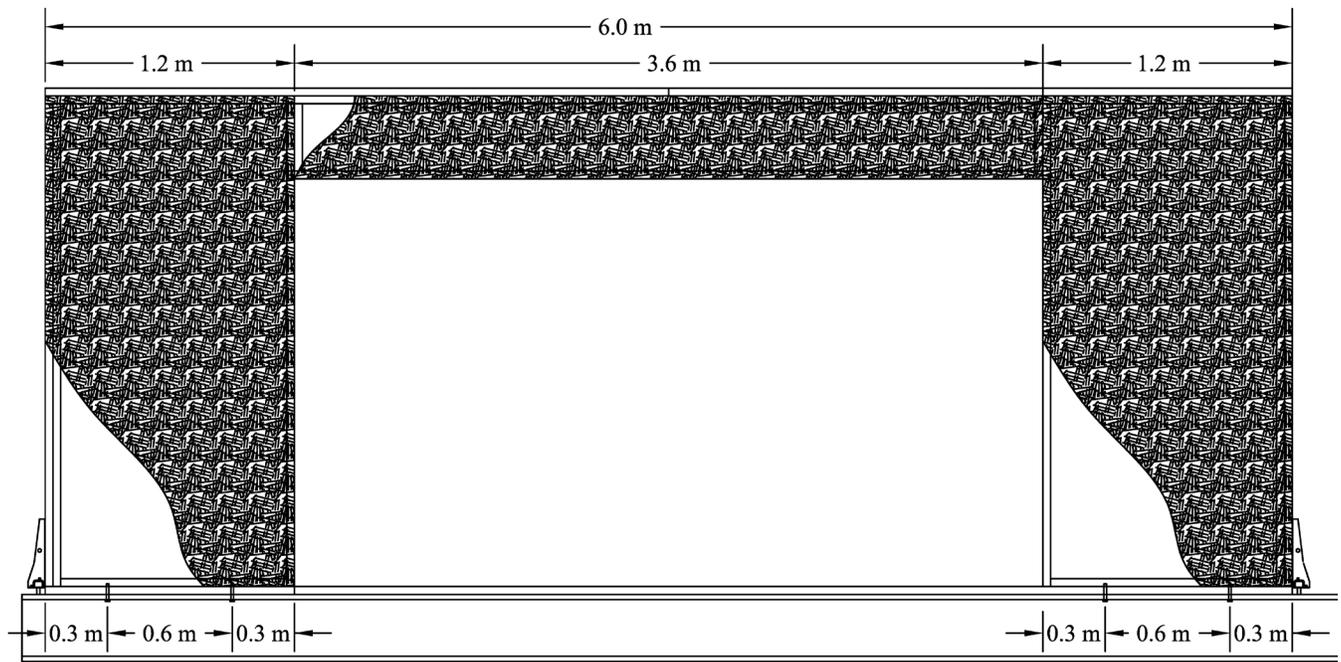
**Figure 5. Configurations for multiple-panel SIP walls with openings.**

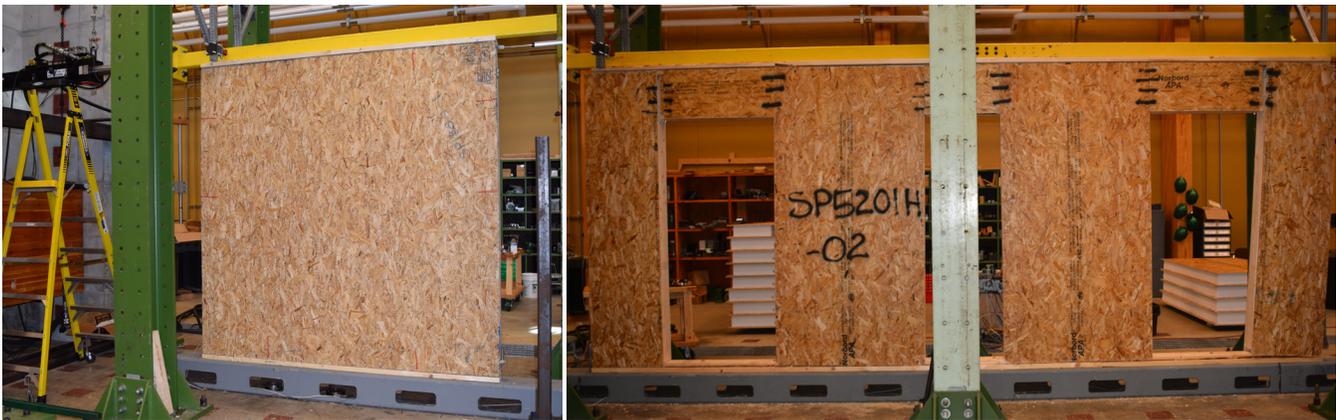
Figure 8. Testing configuration for single- and multiple-panel SIP specimens.

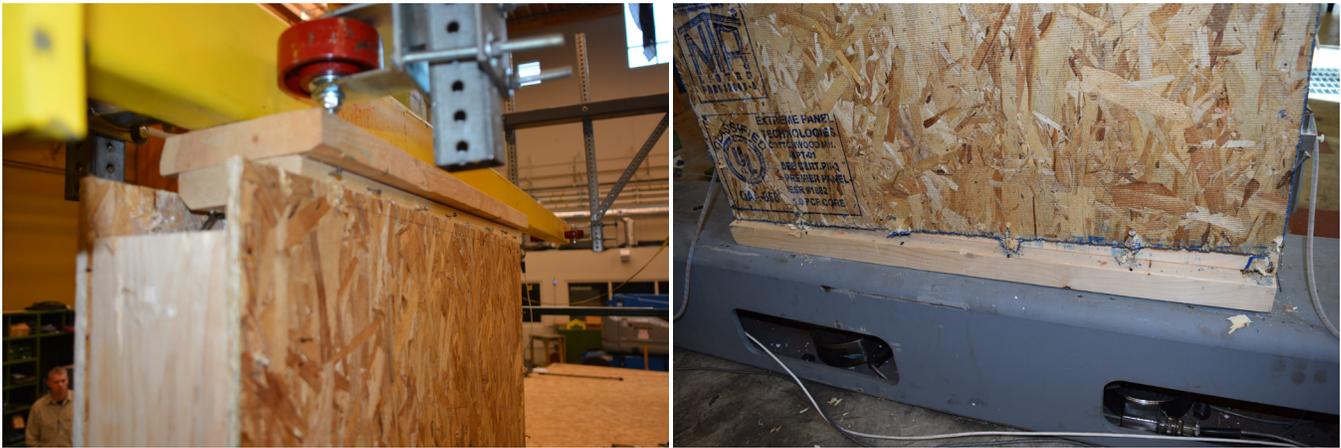
Figure 9. Failure modes for single-panel SIP tests.

For all the single SIP walls with hold-downs, the ultimate mode was the failure of the connection between the let-in framing and OSB panel (Fig. 9). For the 1:1 and 2:1 aspect ratio walls with hold-downs, the walls both slid and rocked during loading, whereas only rocking was observed for the 3:1 and 4:1 aspect ratio walls. Compared with the panels with hold-downs, panels without hold-downs had more failures between the bottom let-in framing and the OSB panel or simultaneous failures at the top and bottom let-in framing and panel. Some let-in framing failed because of cross grain bending. Both the video and graphs of panel uplift showed that the addition of hold-downs significantly decreased the uplift of the end-post and provided an additional load path.

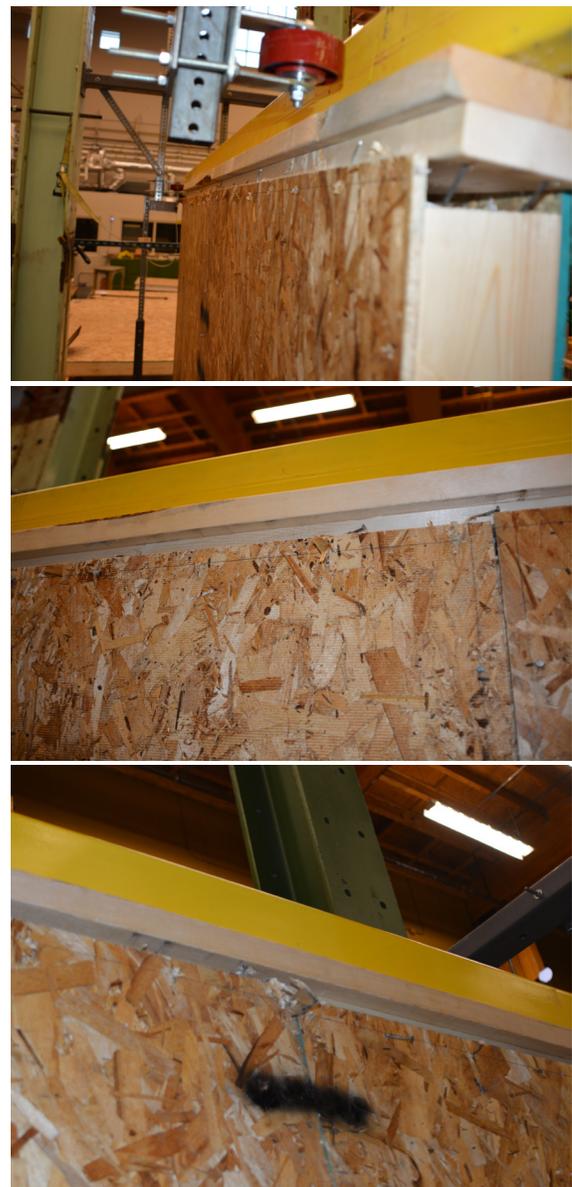
Figure 10. Failure modes for multiple-panel SIP wall without openings.

As with the single-panel tests with hold-downs, all the multiple-panel tests with no openings ultimately failed because the connection between the top let-in framing and the OSB could no longer transfer the loading (Fig. 10). During the test, sliding of the entire wall systems was observed, whereas the individual panels exhibited a rocking behavior. Because of the rocking of the individual panels, the top and bottom corners of adjacent SIP panels exhibited localized crushing. Figure 10 shows typical failures seen for the multiple-panel SIP walls without openings.

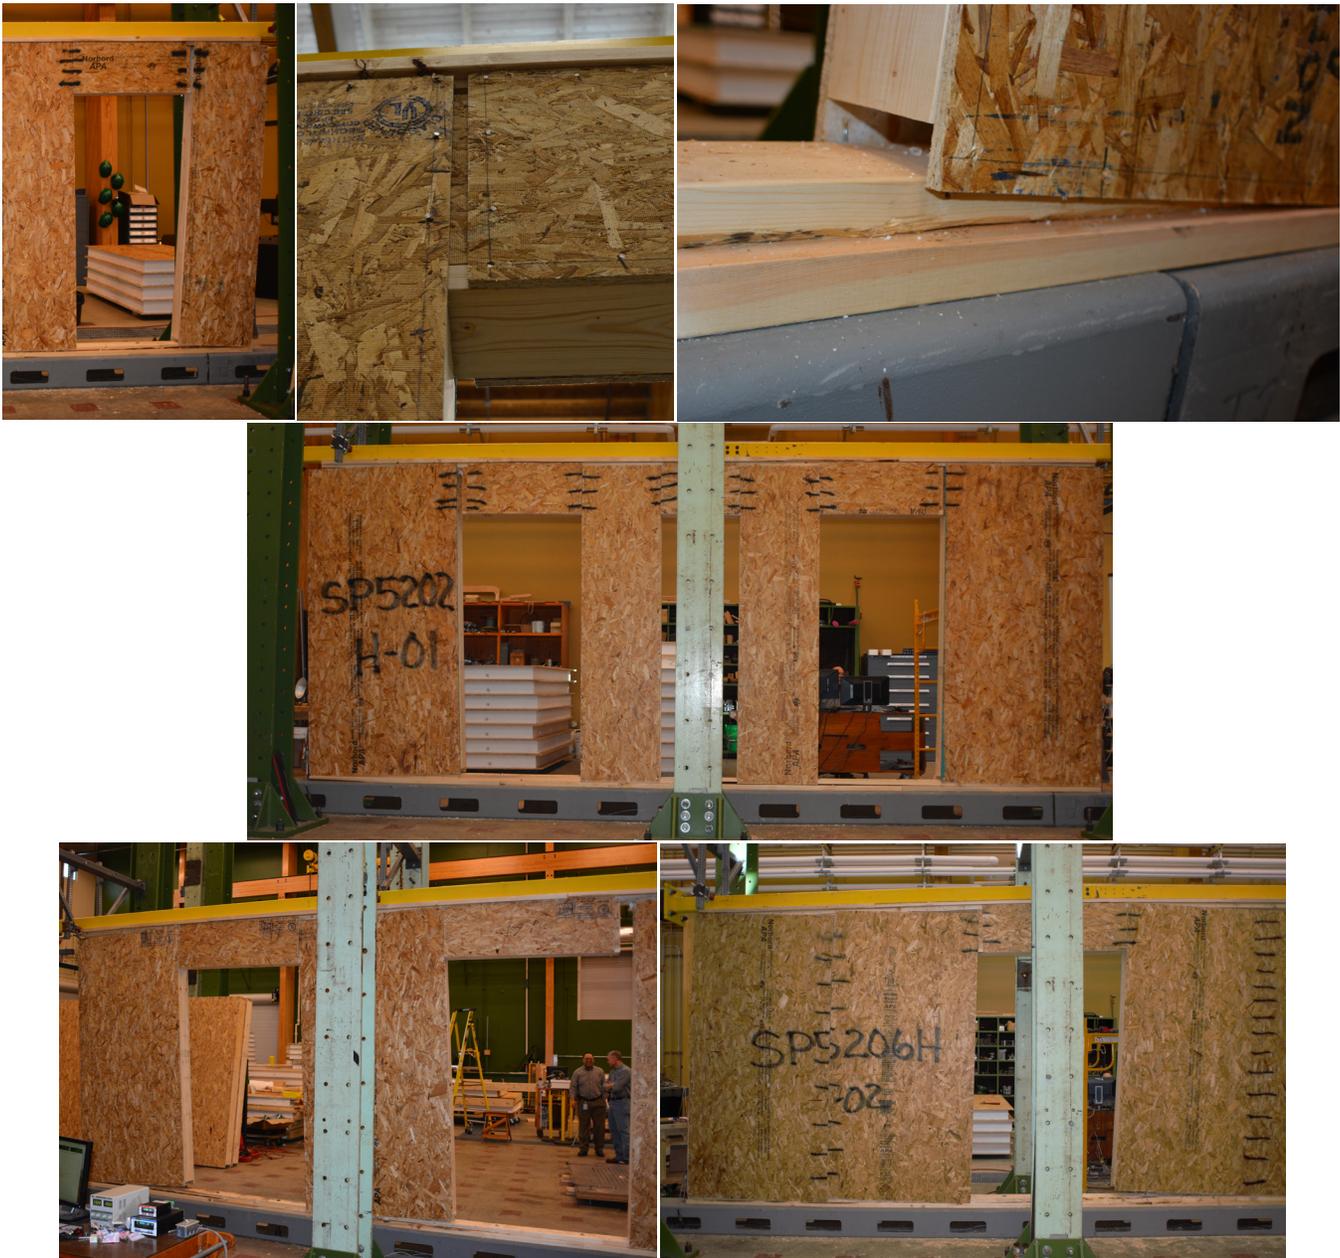
Figure 11. Failure modes for multiple-panel SIP walls with openings.

It was difficult to visually determine precisely when the multiple-panel SIP walls with openings failed, but in general, the connection of the SIP header to the full-size SIP typically weakened and broke first. Depending on the configuration, the continuous built-up top let-in framing and cap plate continued to transfer load to the remaining full-size panels. Upon continued loading, the full-size panels continued to resist applied load via rocking. This led to loosening of the panel-to-panel connection, but the final failure was the let-in framing to panel connection at the top or bottom of the remaining SIP wall. Figure 11 shows

typical failures seen for the multiple-panel SIP walls with openings.

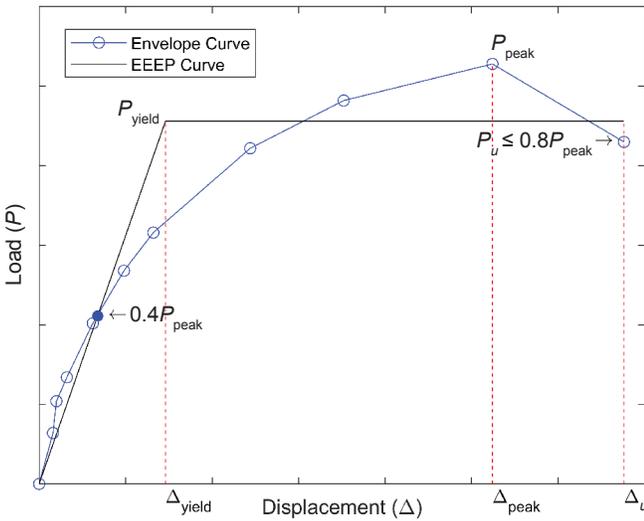
**Figure 12. Equivalent energy elastic-plastic (EEEE) curve and parameters.**

Because of the difficulty in identifying the precise yield strength of the nonlinear SIP resistance deformation response, the equivalent energy elastic–plastic (EEEP) model was used to develop design parameters as shown in Figure 12. The model assumes the energy dissipated

by the test wall during the reversed cyclic loading is equivalent to the energy found under the corresponding bilinear elastic-plastic curve. Only the backbone curve of the reversed cyclic test data was used in the EEE model energy calculations. These parameters included  $\Delta_{yield}$ , displacement at  $P_{yield}$ ,  $\Delta_{peak}$ , displacement at  $P_{peak}$ ,  $P_u$ , and load corresponding to the failure limit. The EEE model approach was used on all the single- and multiple-panel SIP wall cyclic test data. From the backbone curve,  $P_{peak}$ , the maximum absolute load resisted by the specimen and ultimate displacement,  $\Delta_u$ , were determined. Using these values, the yield load,  $P_{yield}$ , can be determined by the following expression:

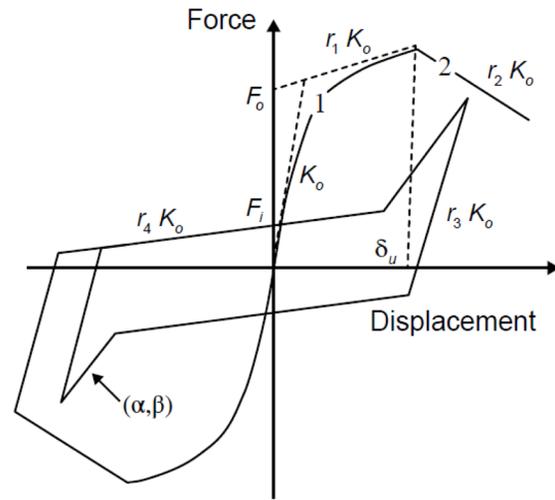
**Figure 13. Modified Stewart hysteretic model and associated parameters.**

modified Stewart and the evolution damage parameter models (Pang and others 2007). For all tested walls, the modified Stewart model was fit to the experimental data. The modified Stewart model uses 10 parameters, highlighted in Figure 13, to describe the hysteretic behavior of the structural panel.

A MATLAB (Mathworks Inc., Natick, Massachusetts, USA) program developed during the NEESWood program was used to optimize the 10 modeling parameters while minimizing the cumulative energy difference between the experimental and model behavior. Average modified Stewart modeling parameters for all SIP wall configurations are listed in Tables 11 to 13. In general, before failure, the modified Stewart model adequately followed the experimental data as observed in the difference between experimental and model cumulative hysteric energy. Appendix C contains tables and cyclic load-deformation curves for experimental and modified Stewart models for all tested walls.

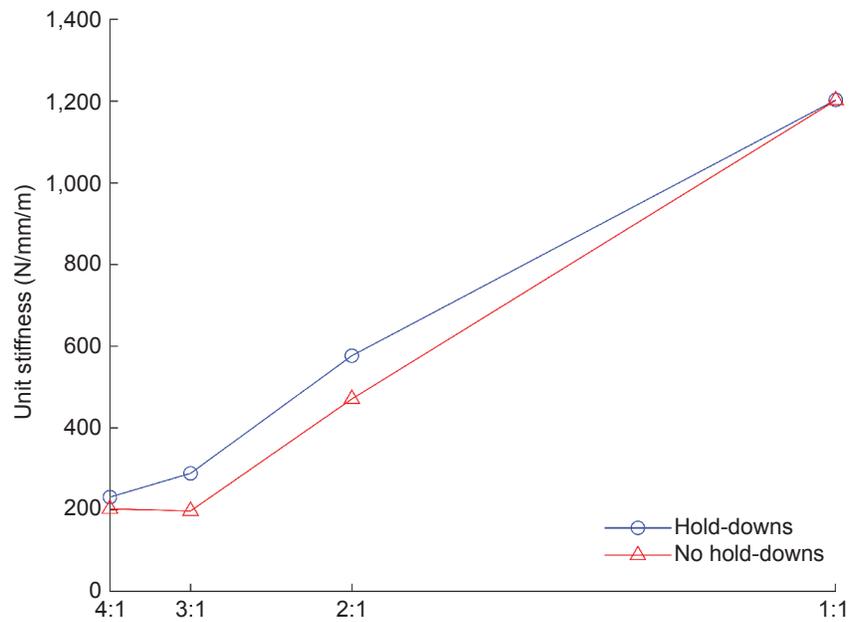
Figure 14. Unit stiffness for single-panel SIP tests with different aspect ratios.

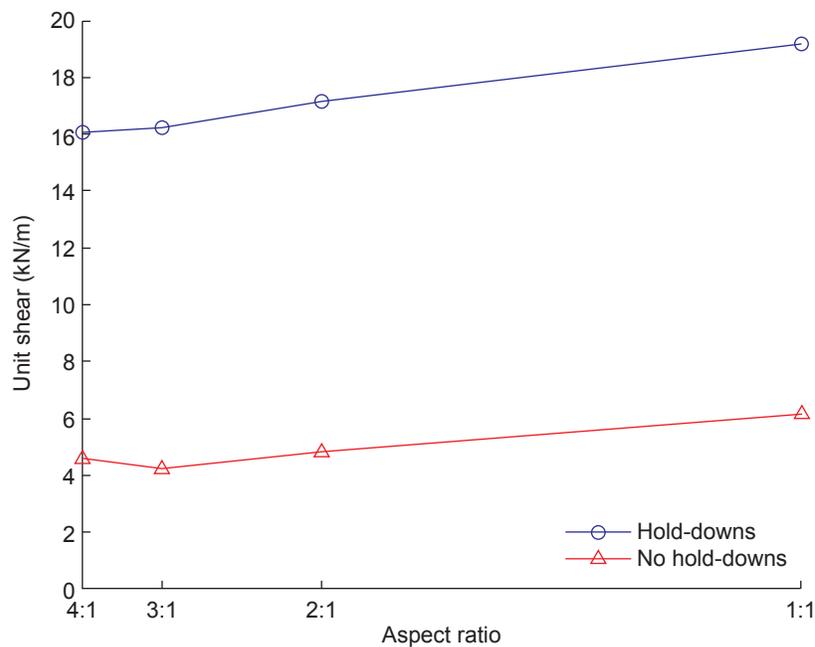
Figure 15. Unit strength for single-panel SIP tests with different aspect ratios.

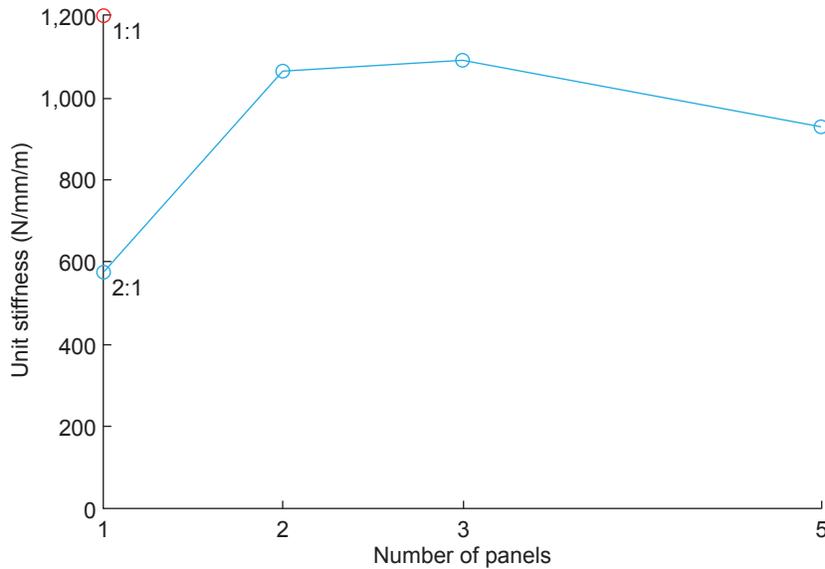
Figure 16. Unit stiffness for multiple-panel SIP tests without openings.

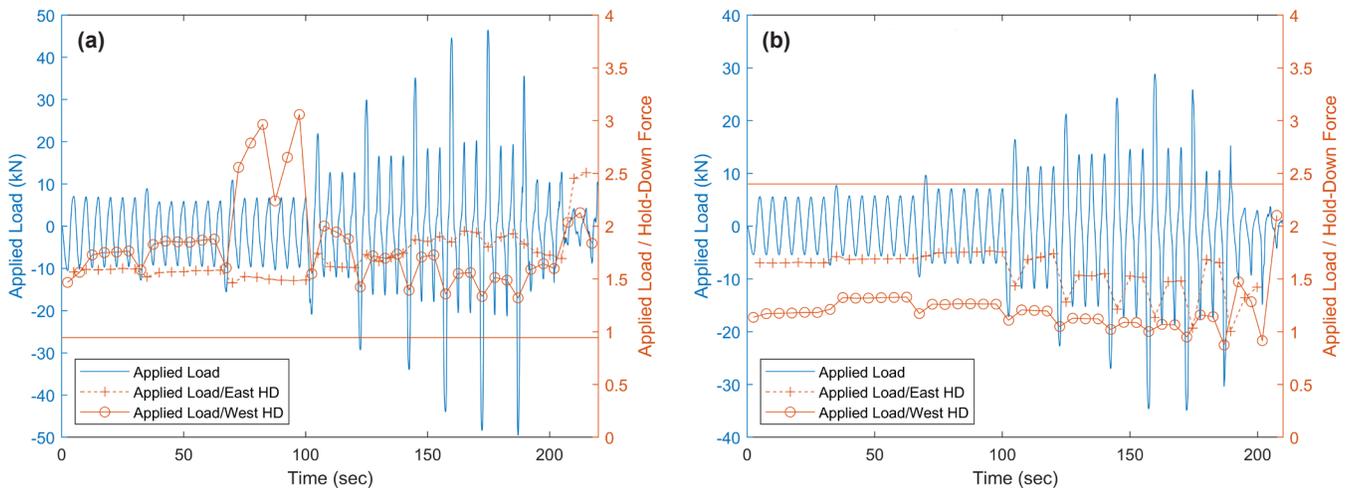
**Figure 18. Ratio of applied load to hold-down force for (a) a representative 2.4- by 2.4-m panel and (b) configuration 207 of the multiple-panel wall with openings.**

load to the hold-down force was calculated. Figure 18 illustrates hold-down forces with respect to applied loading for a 1:1 aspect ratio single-panel wall and a Configuration 207 multiple-panel wall with openings (Table 7). For the single-panel wall, calculated ratios were above the theoretical condition (constant line), which assumes that only the hold-downs resisted the overturning forces. Values above the constant line indicate that other structural components, e.g., anchor bolts, are providing

load paths to resist the applied overturning forces. In the case of multiple-panel wall configurations with openings, Configuration 207 represents the assembly with the largest opening area. For this configuration, the hold-down ratios were below the theoretical ratio (Fig. 18b), which indicates that the maximum resisting moment was not being achieved to resist the applied force.

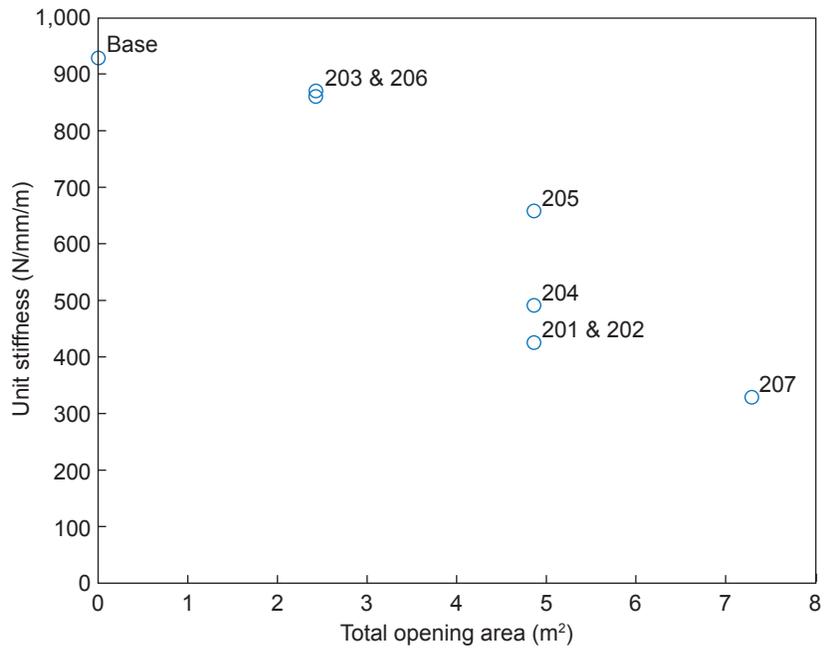
Figure 19. Unit shear wall stiffness for multiple-panel SIP tests with openings.

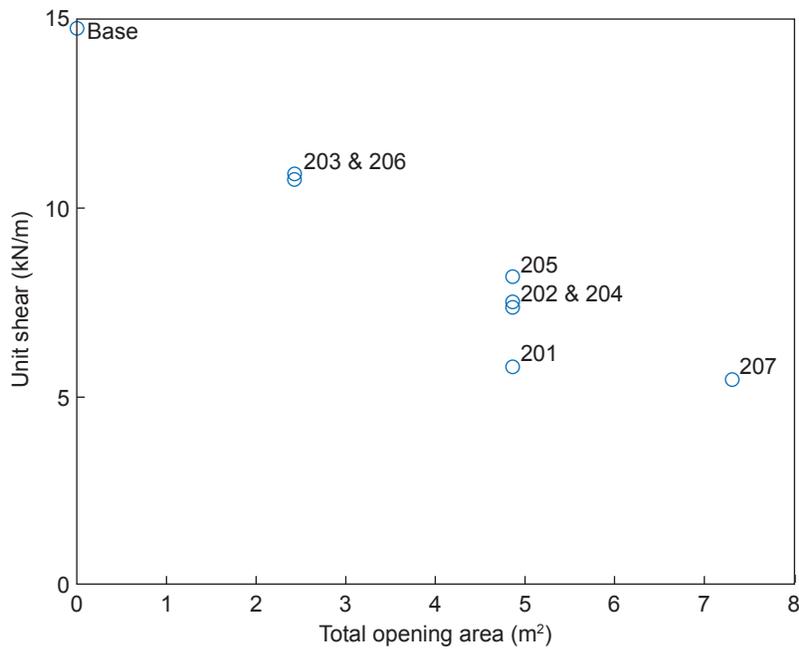
Figure 20. Unit shear wall strength for multiple-panel SIP tests with openings.

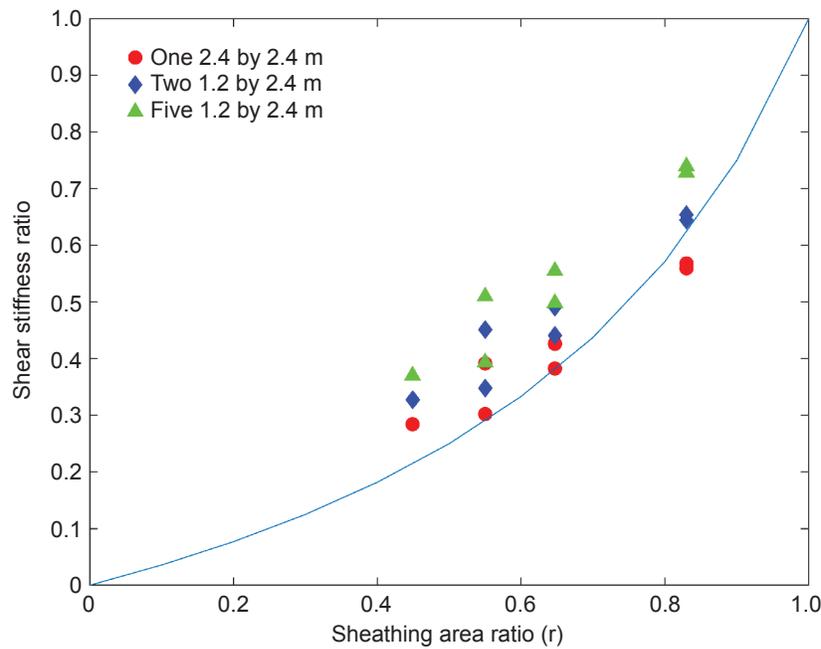
**Figure 21. Perforated shear stiffness ratio using three baseline configurations for shear strength ratio determination.**

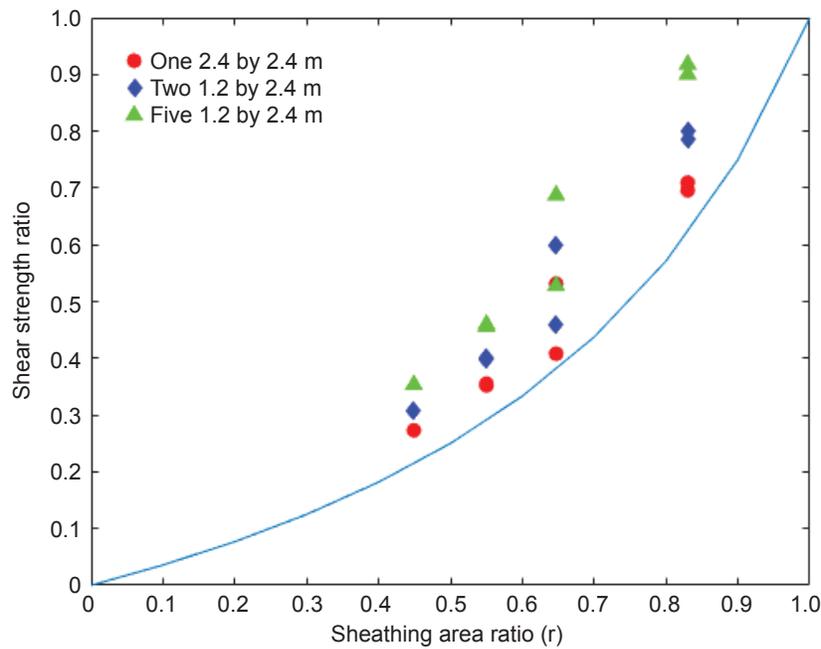
**Figure 22. Perforated shear strength ratio using three baseline configurations for shear strength ratio determination.**

Figure 22 shows that for any choice of baseline, the PSW method gave conservative results for all shear strength ratio predictions. All data points were above the curve and generally followed the shape of the relationship with the sheathing ratio. The most conservative results came from using the five 1.2- by 2.4-m (4- by 8-ft) panel configuration as the baseline. Based on these configurations, it appeared to be justified to apply the PSW approach to SIP wall configurations with openings. Furthermore, using a 2.4- by

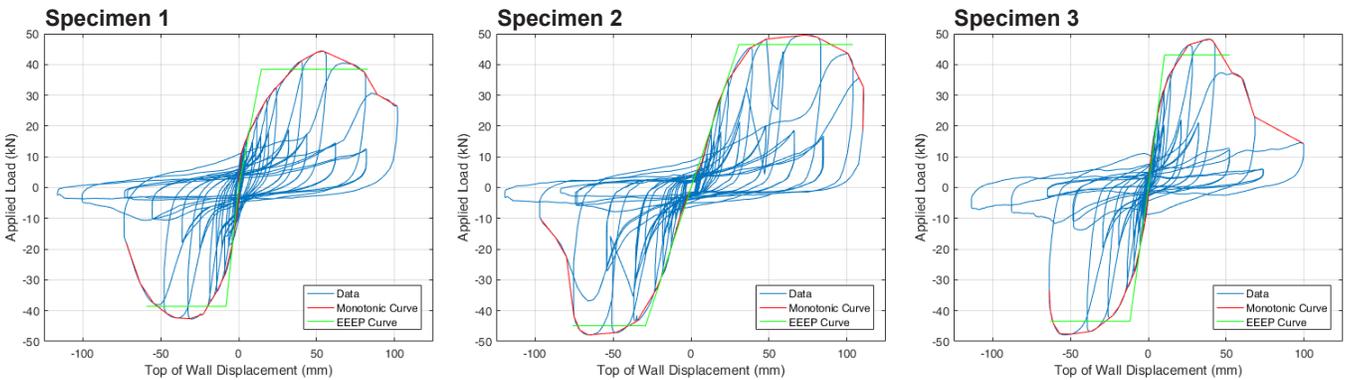
**Figure B1. EEEP curves for SIPs with a 1:1 aspect ratio (2.4 by 2.4 m).**

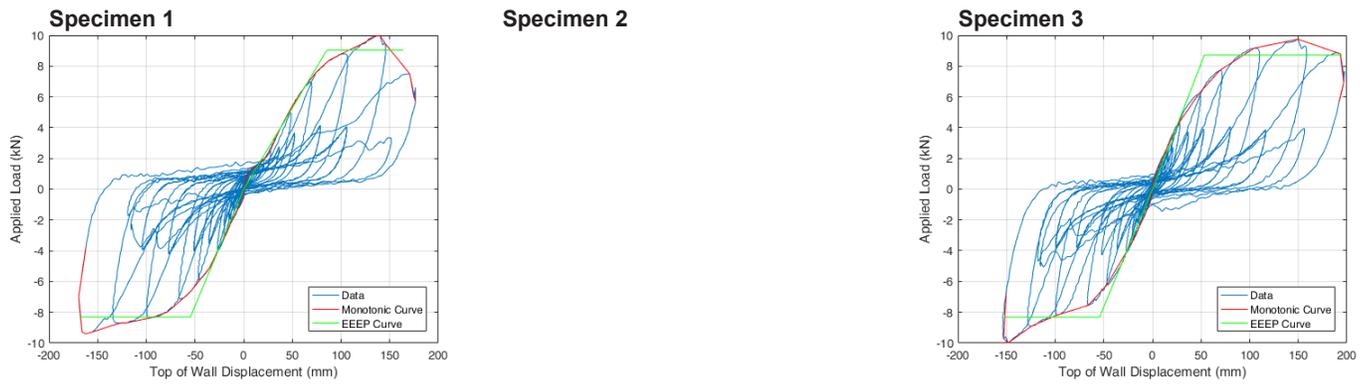
Figure B4. EEEP curves for SIPs with a 4:1 aspect ratio (0.6 by 2.4 m). (Initial misalignment caused pulse displacement in first cycle, which led to unbalanced cyclic loading. No graph provided for Specimen 2.)

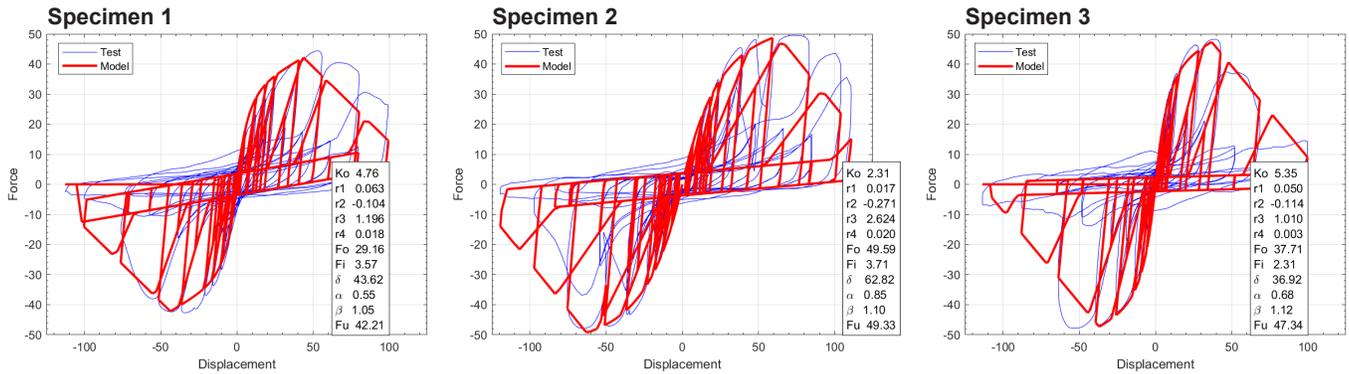
**Figure C1. Modified Stewart curves for SIPs with a 1:1 aspect ratio (2.4 by 2.4 m).**
