# Performance of Structural Insulated Panel Walls under Seismic Loading

Research Paper  
FPL–RP–704

September  
2020

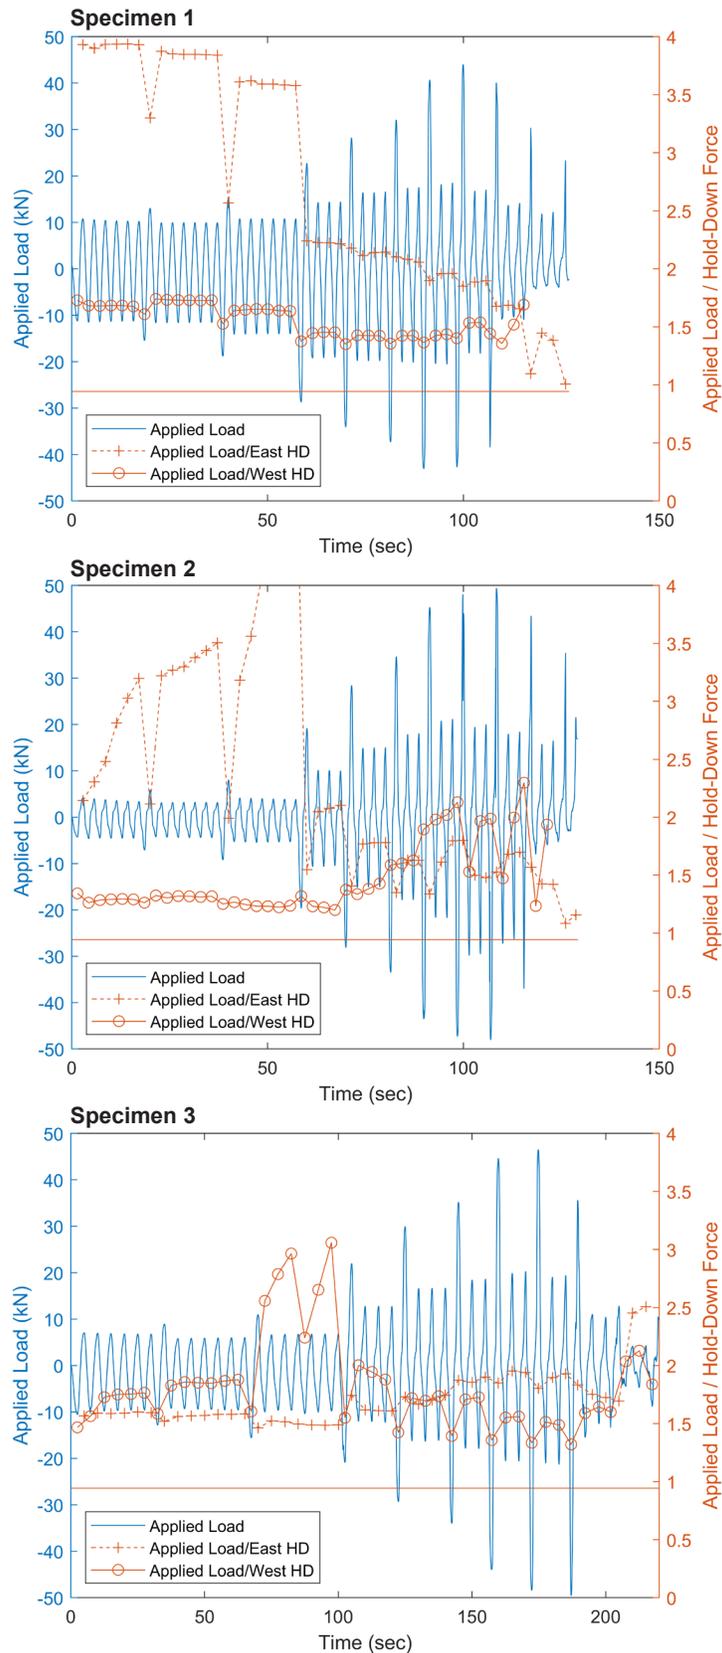
Figure D1. Ratios of applied load to hold-down force for single-panel SIPs with 1:1 aspect ratio.
